MANDATORY SERVICE BULLETIN

IS-29D2/IS-29D/EO-14

SUBJECT: GLIDER IS-29D2/IS-29D
Increase of the safe life until the first overhaul and between overhaul and between overhauls. Introduction of a maintenance schedule without limit of the calendaristic period until the first overhaul or between two overhauls.

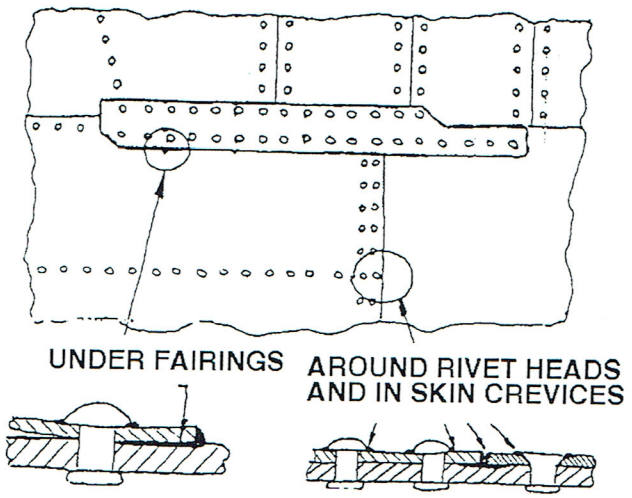
Fig. 4-1/Section 4/Para. 400 of AC 43-4A

3.1. The external surfaces (skins) are protected by finish priming and painting. In the area of riveted wing skins, corrosion may occur around the rivets.
These defects may occur as shown in fig. 4-1.

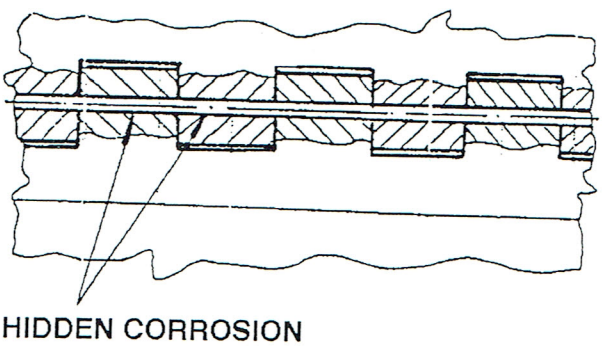
Fig. 4-7/Section.4/Para. 406 of AC-43-4A

The effect of the corrosion types described above may be noticed firstly by the cracking and blistering of the paint coat.

3.2. The hinges type piano-chord are particularly exposed to corrosion due to the contact between different metals (aluminium alloy and steel) as shown in fig. 4-7.

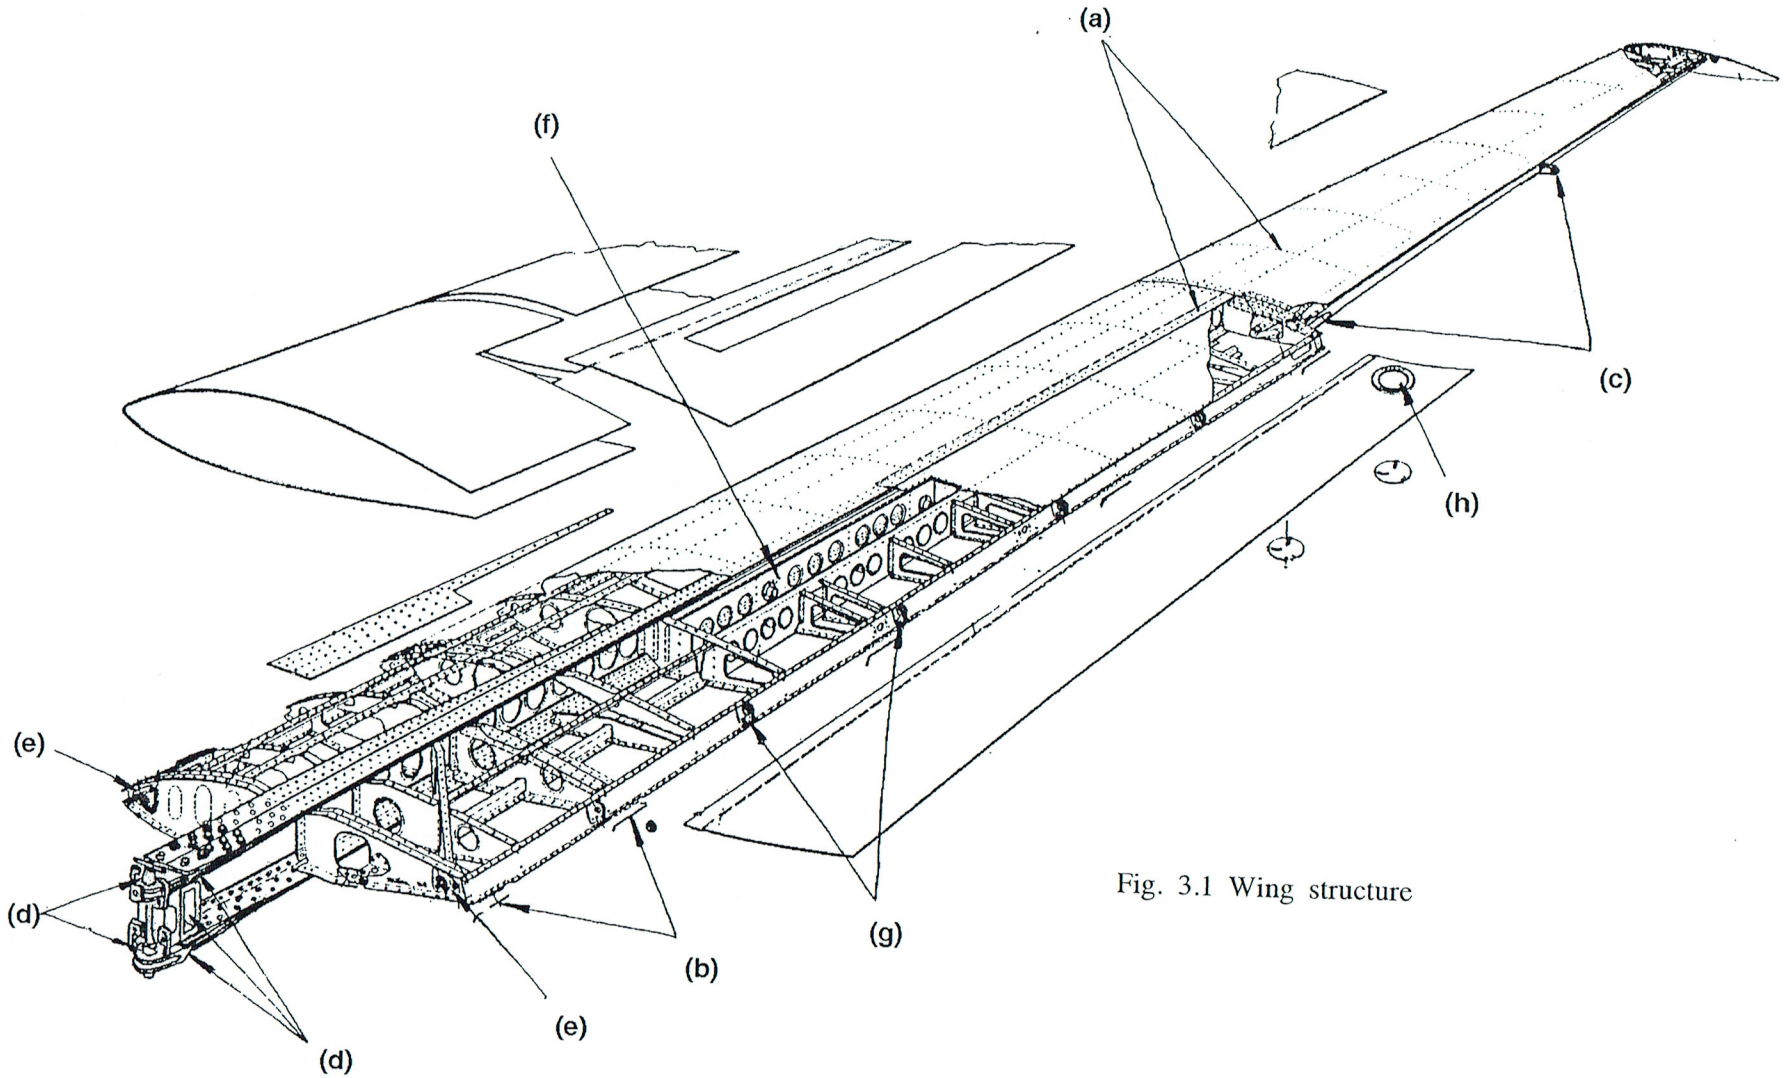
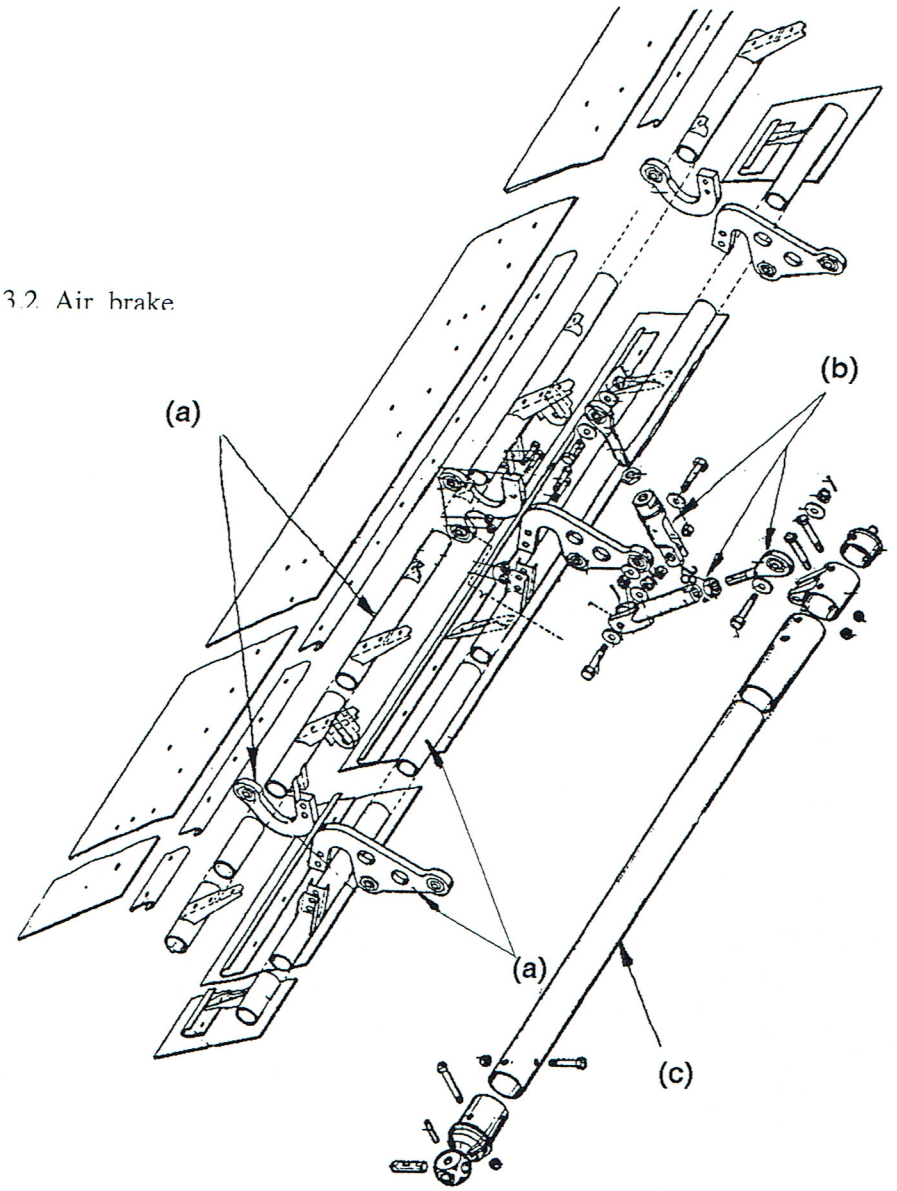
Fig. 3.1 Wing structure

3.3. The corrosion check for the wing consists in :

(a) Skin and riveting area check according to the indications of point 3.1.
(b) Check of flaps attachment hinges as shown to point 3.2.
(c) Check of aileron supports and joint shaft.
(d) Check of junction fittings, link fittings and junction bolts.
(e) Check of flanges and relevant fittings.
(f) Check of air brake housing.
(g) Check of control rod supports.
(h) Check of areas near the inspection covers and draining holes.

NOTE : The points (a) to (h) are to be found on fig. 3.1.

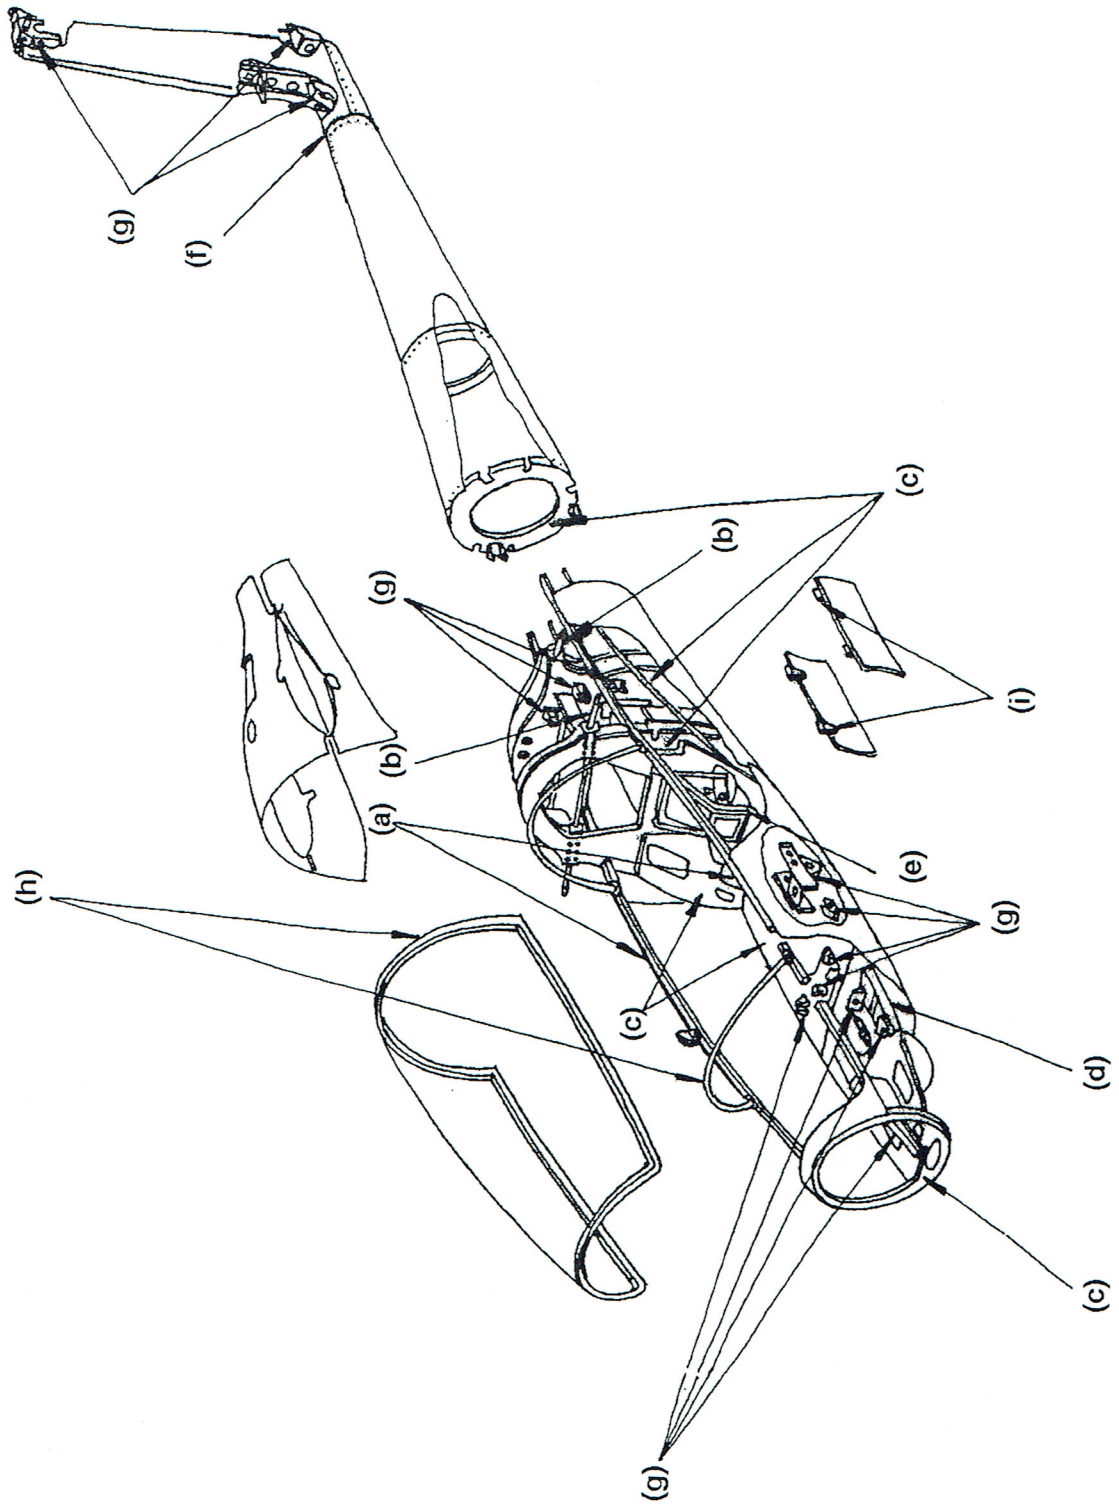
Fig. 4.1 Fuselage structure

The areas to be carefully checked are the following (see fig. 4.1) :

(a) Spars-integrity check.
(b) Junction bolts and pins.
(c) Fuselage frames and panels.
(d) Release mounting area.
(e) Landing gear mounting area.

(f) Fuselage-to-fin junction area.
(g) Fuselage and fin control supports.
(h) Fixed arcade and canopy structure.
(i) Landing gear trap hinges.

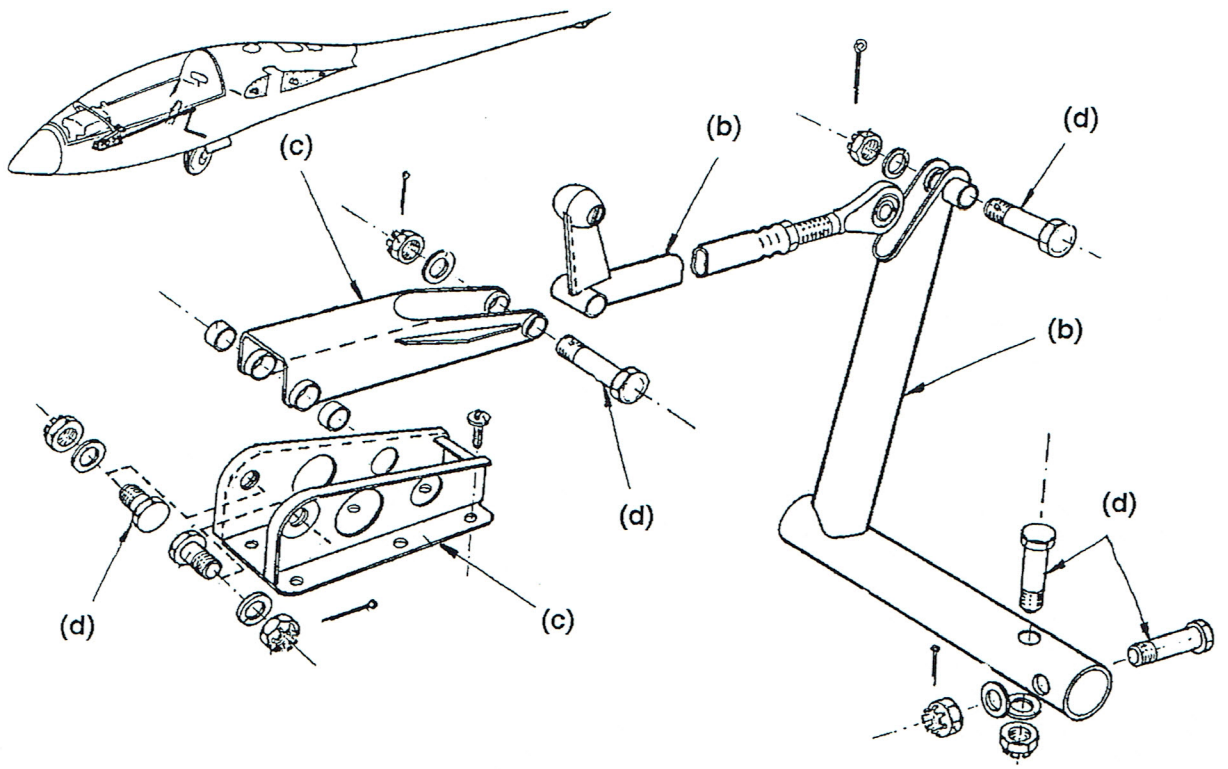
Fig. 6.1 Landing gear retracting control

The control rods particularly exposed to corrosion due to the contact between different metals (aluminium alloy and steel) shall be checked to all the glider controls.

Landing gear retracting control (Fig. 6.1); aileron control (Fig. 6.2); elevator control (Fig. 6.3); rudder control (Fig. 6.4); air brake and flap control (Fig.6.5); trimmer control (Fig. 6.6); release control, wheel brake control.

The priority areas to be checked within the control linkage shall be (Fig. 6.1 to 6.6) :
